NASA TN D-2391

YLR99-RM-1 ROCKET ENGINE OPERATING EXPERIENCE IN THE X-15 AIRCRAFT

*Flight Research Center
Edwards, Calif.*

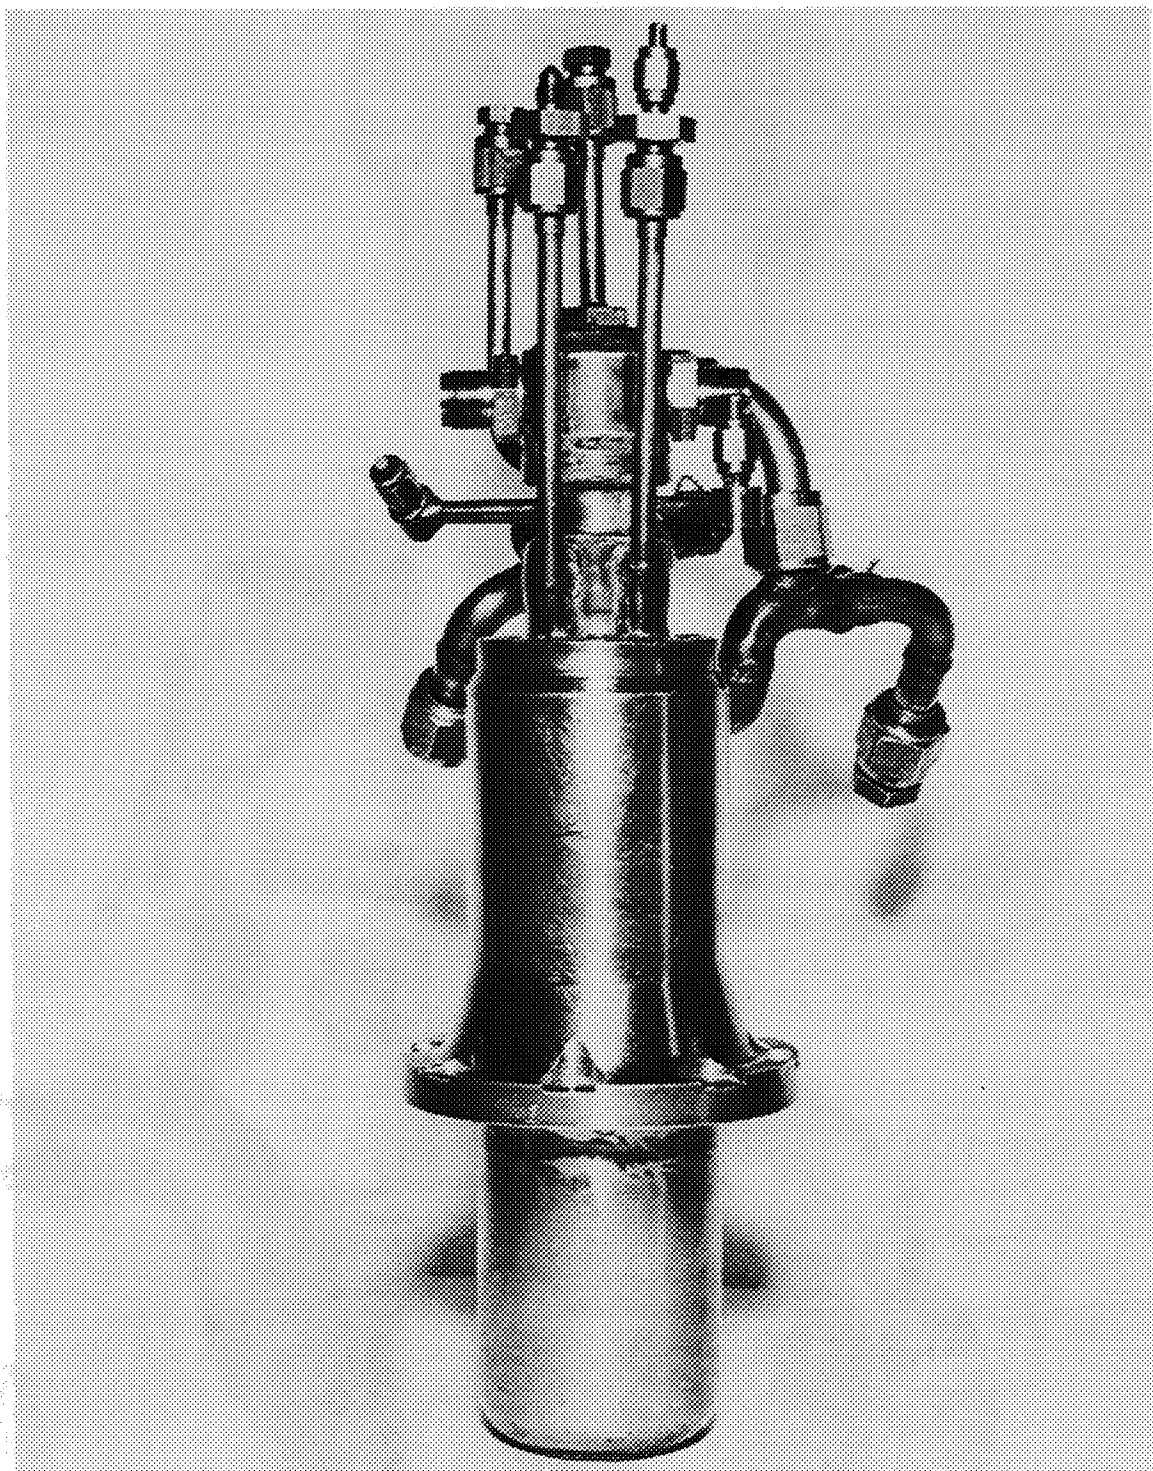
Figure 4.- Photographs of damaged igniter.

The igniter used in the YLR99 engine is a two-stage unit providing an ignition source for the main chamber. Three spark plugs in the first stage initiate the combustion process. Explosions in the igniter at the time of engine shutdown have been a significant problem (ref. 1). The explosions have occurred only during what is referred to as a "lox depletion shutdown," that is, the engine shuts down automatically when the liquid-oxygen tank empties before the fuel in the ammonia tank is depleted. Such shutdowns did not occur during the early X-1 flights. For these flights, the full capacity of the propellant tanks was not needed, and engine shutdown was the result of pilot action. The explosions were presumably, the result of reverse flow which permitted unburned ammonia to pass from the combustion chamber into the oxygen manifold of the second-stage igniter where it mixed with residual oxygen and subsequently detonated. Figures 4(a) and 4(b) show the damage that resulted from such explosions.

(a) General view.

In order to operate around the igniter-explosion problem, pending a solution, the X-15 was programmed only for fuel-depletion shutdowns to prevent any further igniter damage. An auxiliary purge system is being installed as a permanent solution. This system consists of a regulated helium supply which pressurizes the igniter liquid-oxygen supply system when liquid-oxygen pump discharge pressure decays.

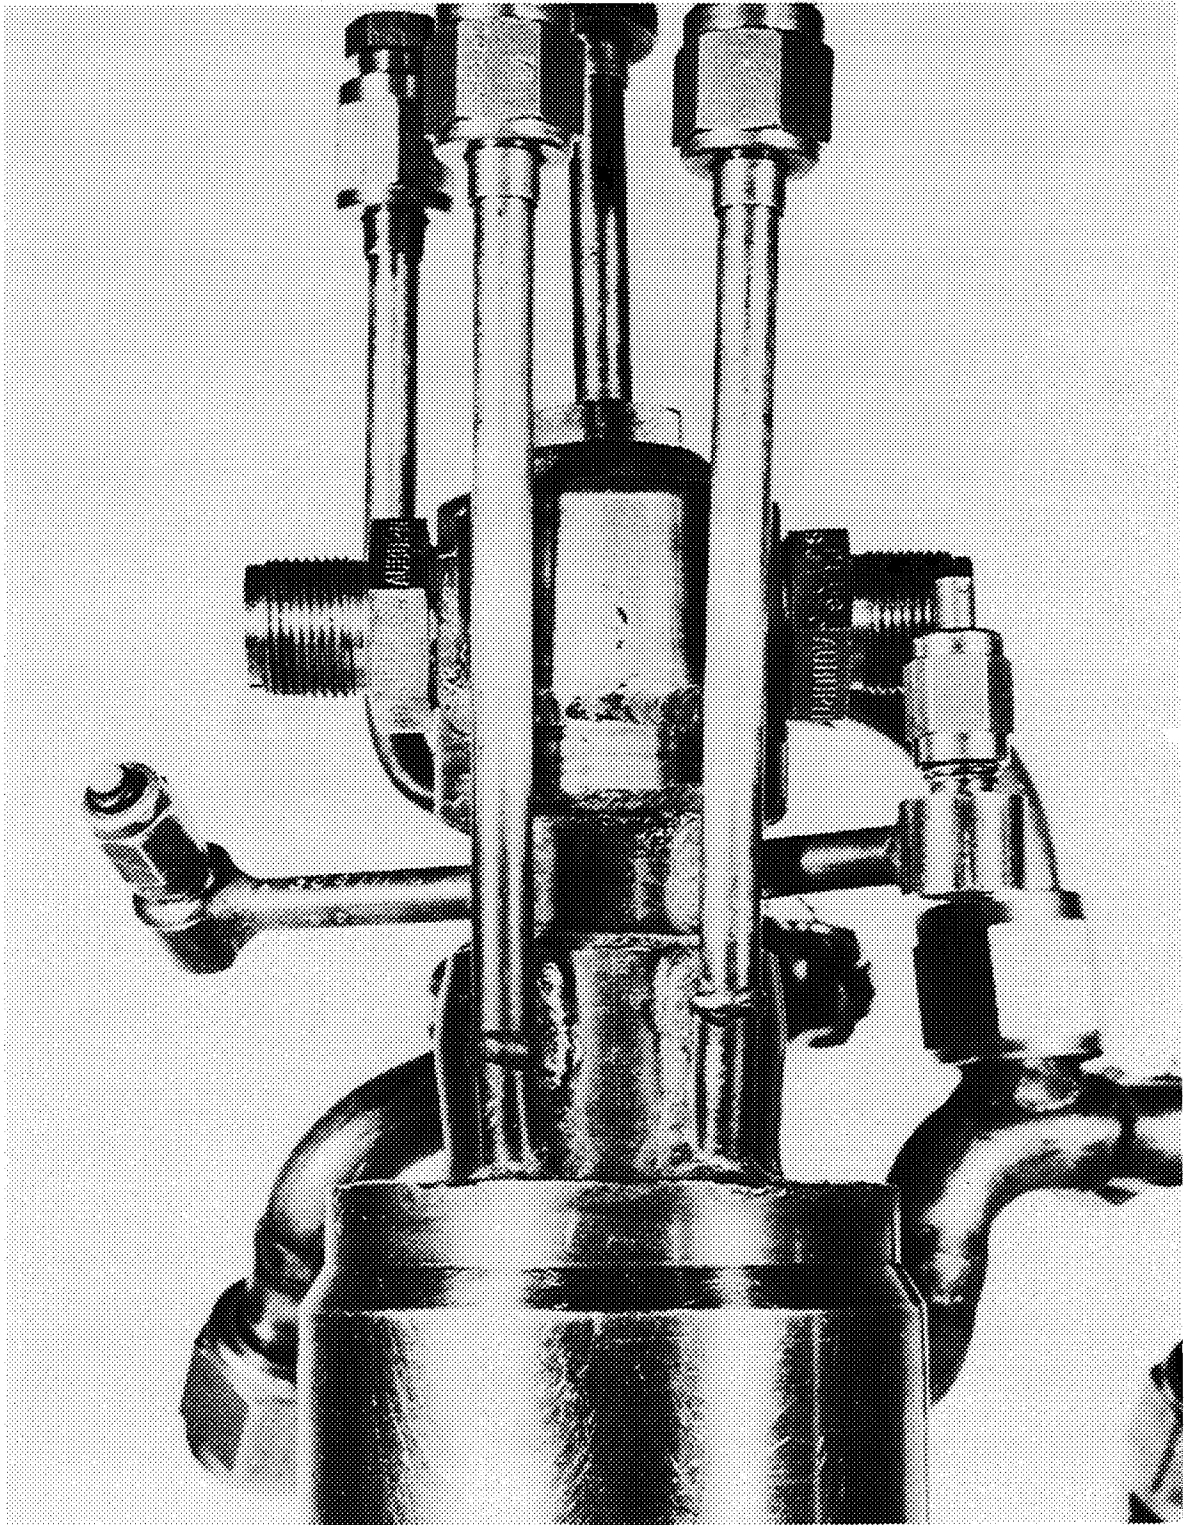
Figure 4.- Concluded.

(b) Closeup showing bulged cooling-jacket wall.

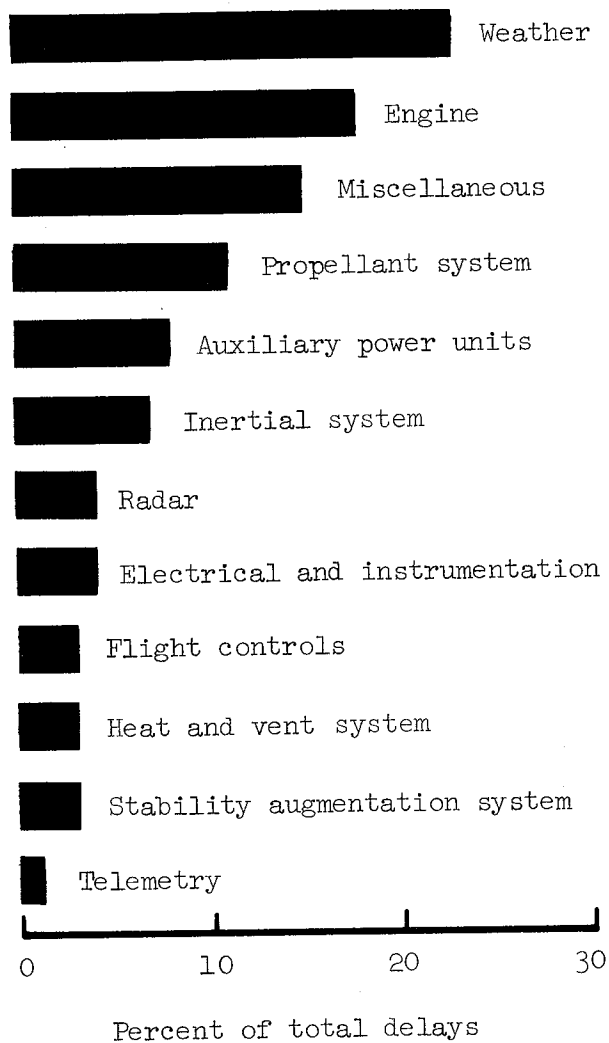
Figure 5.- Sources of flight cancellations during the first 50 Government flights with the YLR99 engine.

The relative proportions of X-15 flight delays from various causes are illustrated in figure 5. As shown, the YLR99 rocket engine caused more delays than any other single factor except weather. In the few instances in which two problems occurred, either of which would cause a delay, both are included. The miscellaneous bar accounts for problems of less than 2-percent frequency.

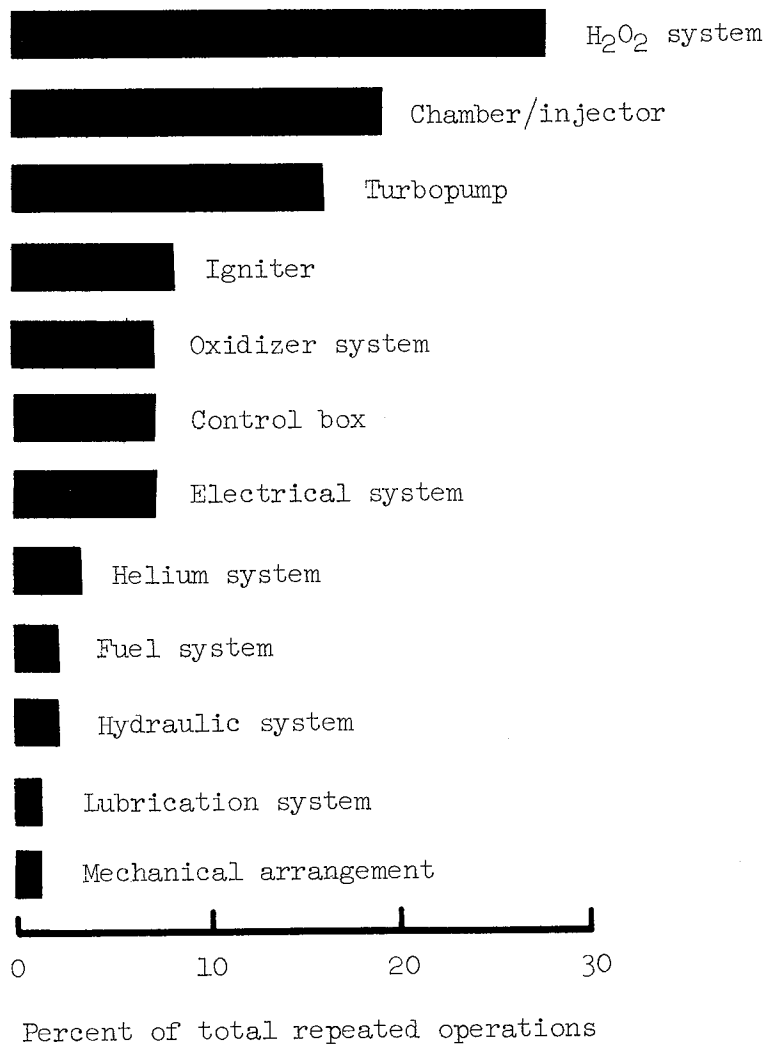
Figure 7.- YLR99 engine problems causing repeated operations.

Figure 7 indicates the systems responsible for repeated operations, that is, additional operations required to qualify an engine for aircraft installation or

flight when the initial qualification run was unsuccessful. Included are instances when failure to qualify resulted in removal of the engine from the aircraft. As shown, the H₂O₂ system was the cause of nearly 30 percent of the total repeated operations. The thrust chamber and turbopump also caused a large percentage of repeated operations.
